Eve Borsook

The Materials and Condition of the Last Judgement Mosaic of Prague Cathedral*

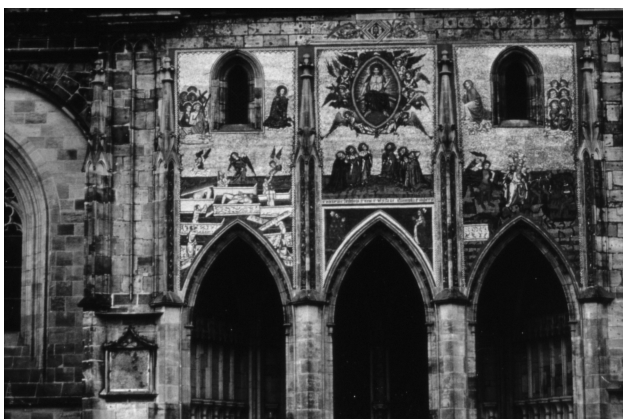
Fig. 1. Prague, Cathedral of St. Vitus. The mosaic after cleaning and regilding by Getty Conservation Center and Czech conservators.

The recently cleaned Prague mosaic (Figs. 1–4) presents a series of problems typical of medieval mosaics elsewhere. Although studies of style and meaning abound, too little has been done for an understanding of the nature of the materials and how they were used. The reason for this, as I am sure you are well aware, is that so few samples for analyses have been taken and at that, quite sporadically and often incompletely examined. For instance, for the Florentine Baptistery only 13 samples were analyzed—all from the early 14th century mosaics in the gallery.¹ None were taken from the earlier vault mosaics. At the Sancta Sanctorum in

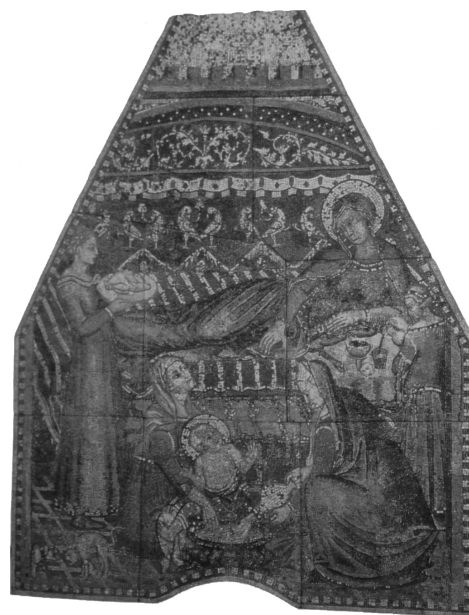
Fig. 5. London, Victoria and Albert Museum. Birth of the Virgin, detached mosaic from façade of Orvieto Cathedral.

A very rough calculation of how much 660 lbs of glass tesserae would make in terms of a mosaic surface—turns out to be about 12 square metres or about 10% of the Orvieto façade mosaic.²⁰ So far, no soda glass tesserae have been identified among the ruined remains of the Orvieto mosaics (Fig. 5) but this may be due to lack of analysed samples.²¹ In any case, the late Trecento documents tell us that the façade mosaics there made by Orcagna and others were defective because they were badly set and discolored. Hardly were the individual scenes finished than repairs and restorations ensued.²² For a complete study of their complicated history, see the recent article by Giulio Manieri Elia and Paul Tucker.²³

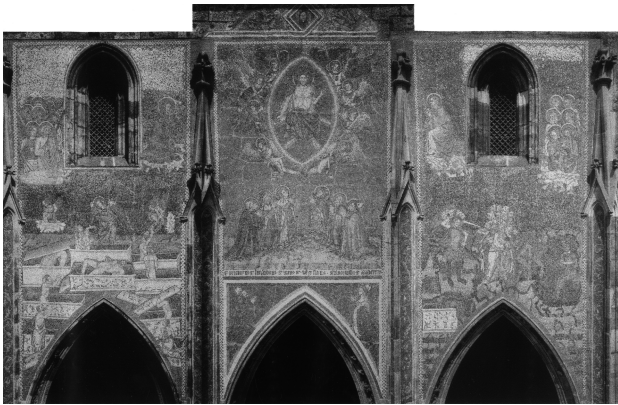
Hettes also noted another interesting feature in the Prague mosaic: the different color of the support glass for the metallic tesserae (Fig. 6). Red predominates in the central panel giving the main scene a warmer glow while dark green and blue were used for the flanking mosaics.⁴² It is known that red glass without lead in it is not ideal for the adherence of metal foil (does the Prague mosaic have lead in its red support tesserae?). Green and blue glass are better in this respect.⁴³ In fact, this is mentioned in a 15th-century mosaic treatise published by Milanese in the 19th century.⁴⁴ Were the Prague mosaicists aware of this? Another question:

Fig. 6. Prague Cathedral. View of mosaic after cleaning and before regilding by the Getty Conservation Center and Czech conservators.

- 42 HETTES, 1958, p. 3. The red glass in the central panel, along with the green and blue grounds on ei-

ther side, were regilded during the Getty sponsored conservation campaign.
